TECHNICAL INSPECTION REPORT

6 OPERATION CROSSROADS.
U.S.S. CRITTENDEN (APA 77)

TEST ABLE.

VOLUME 2 [U].

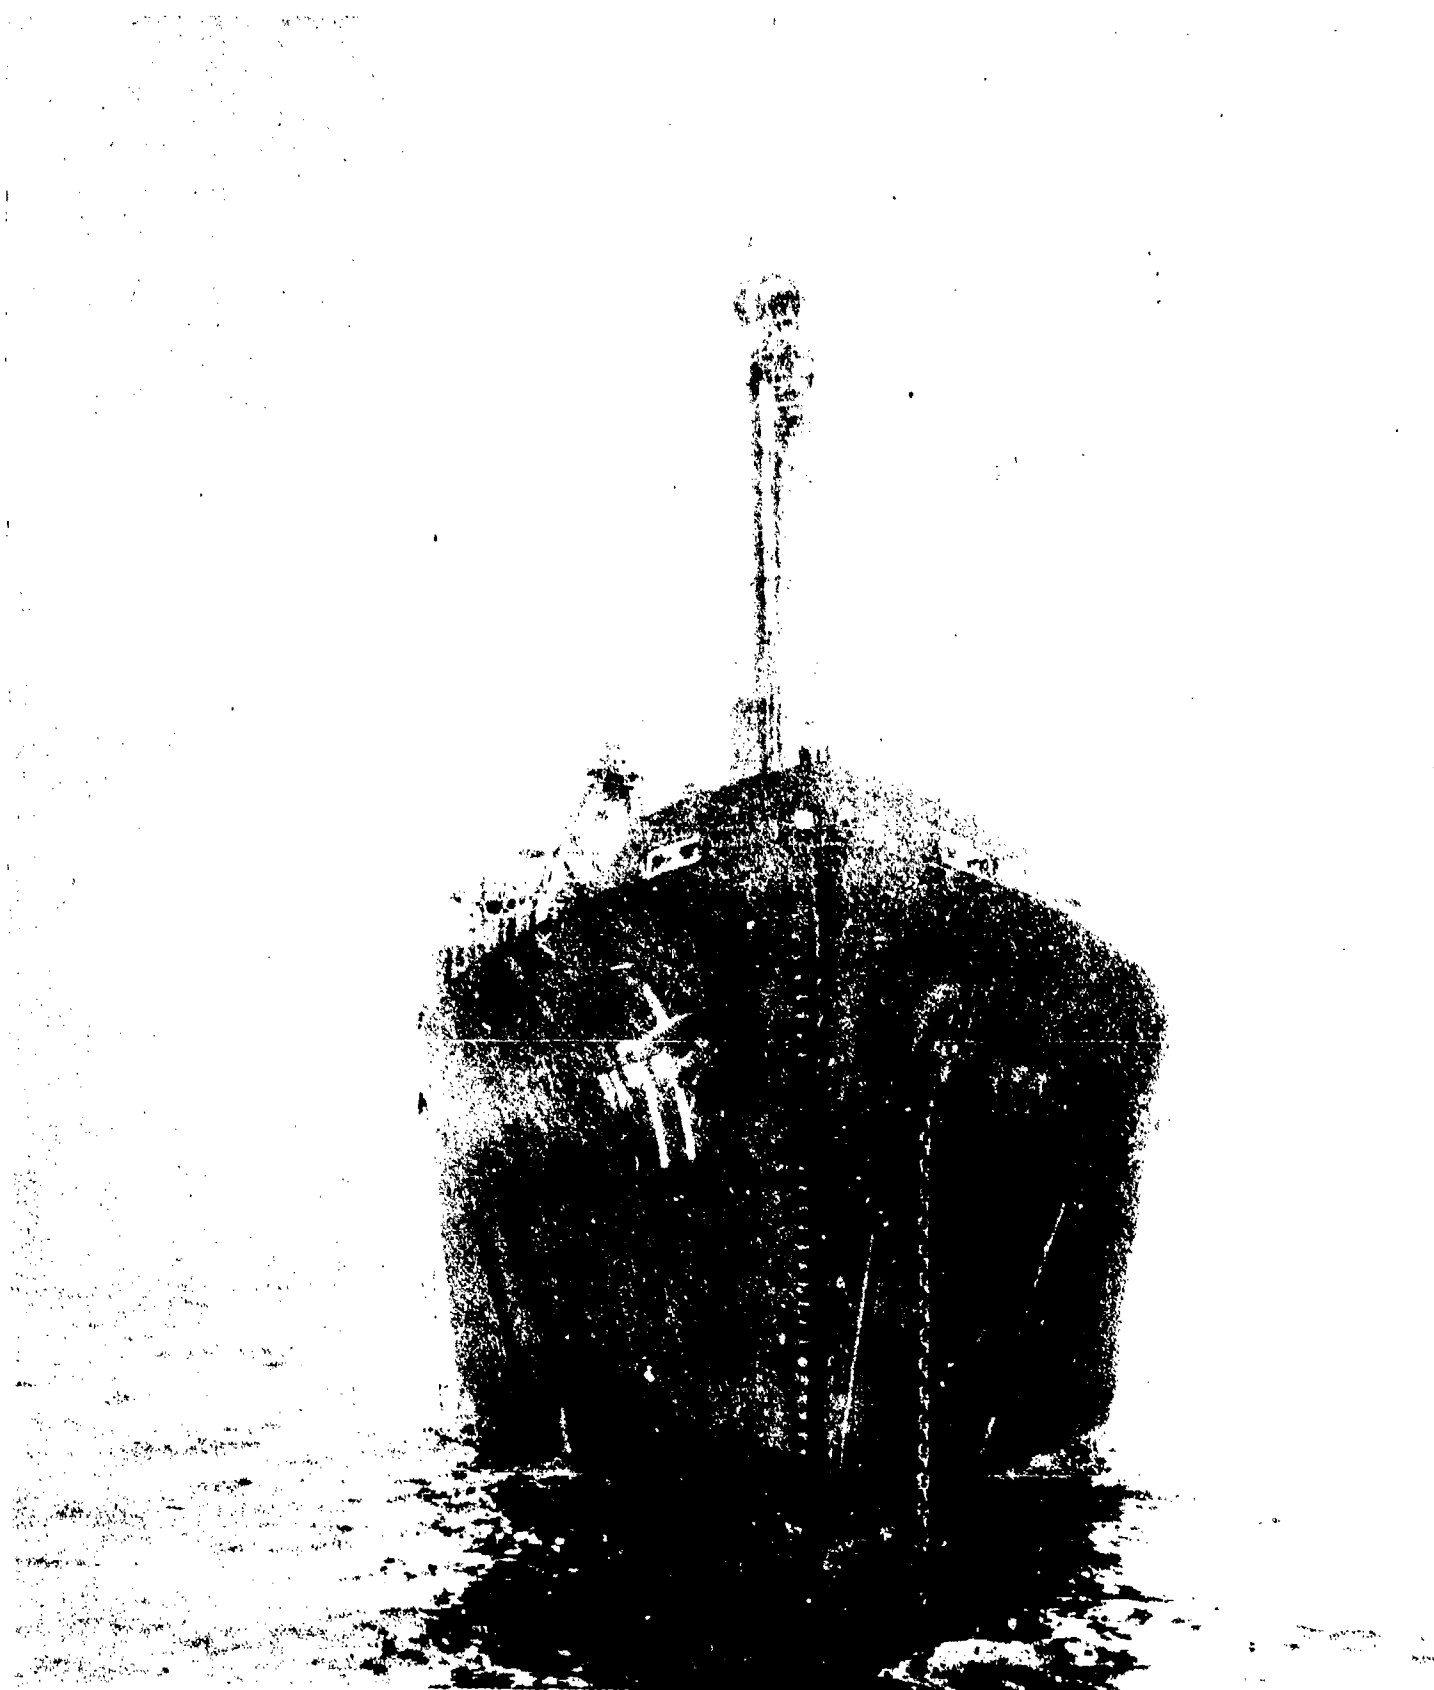
AA-CR-227-49-118. After test. Bow view.

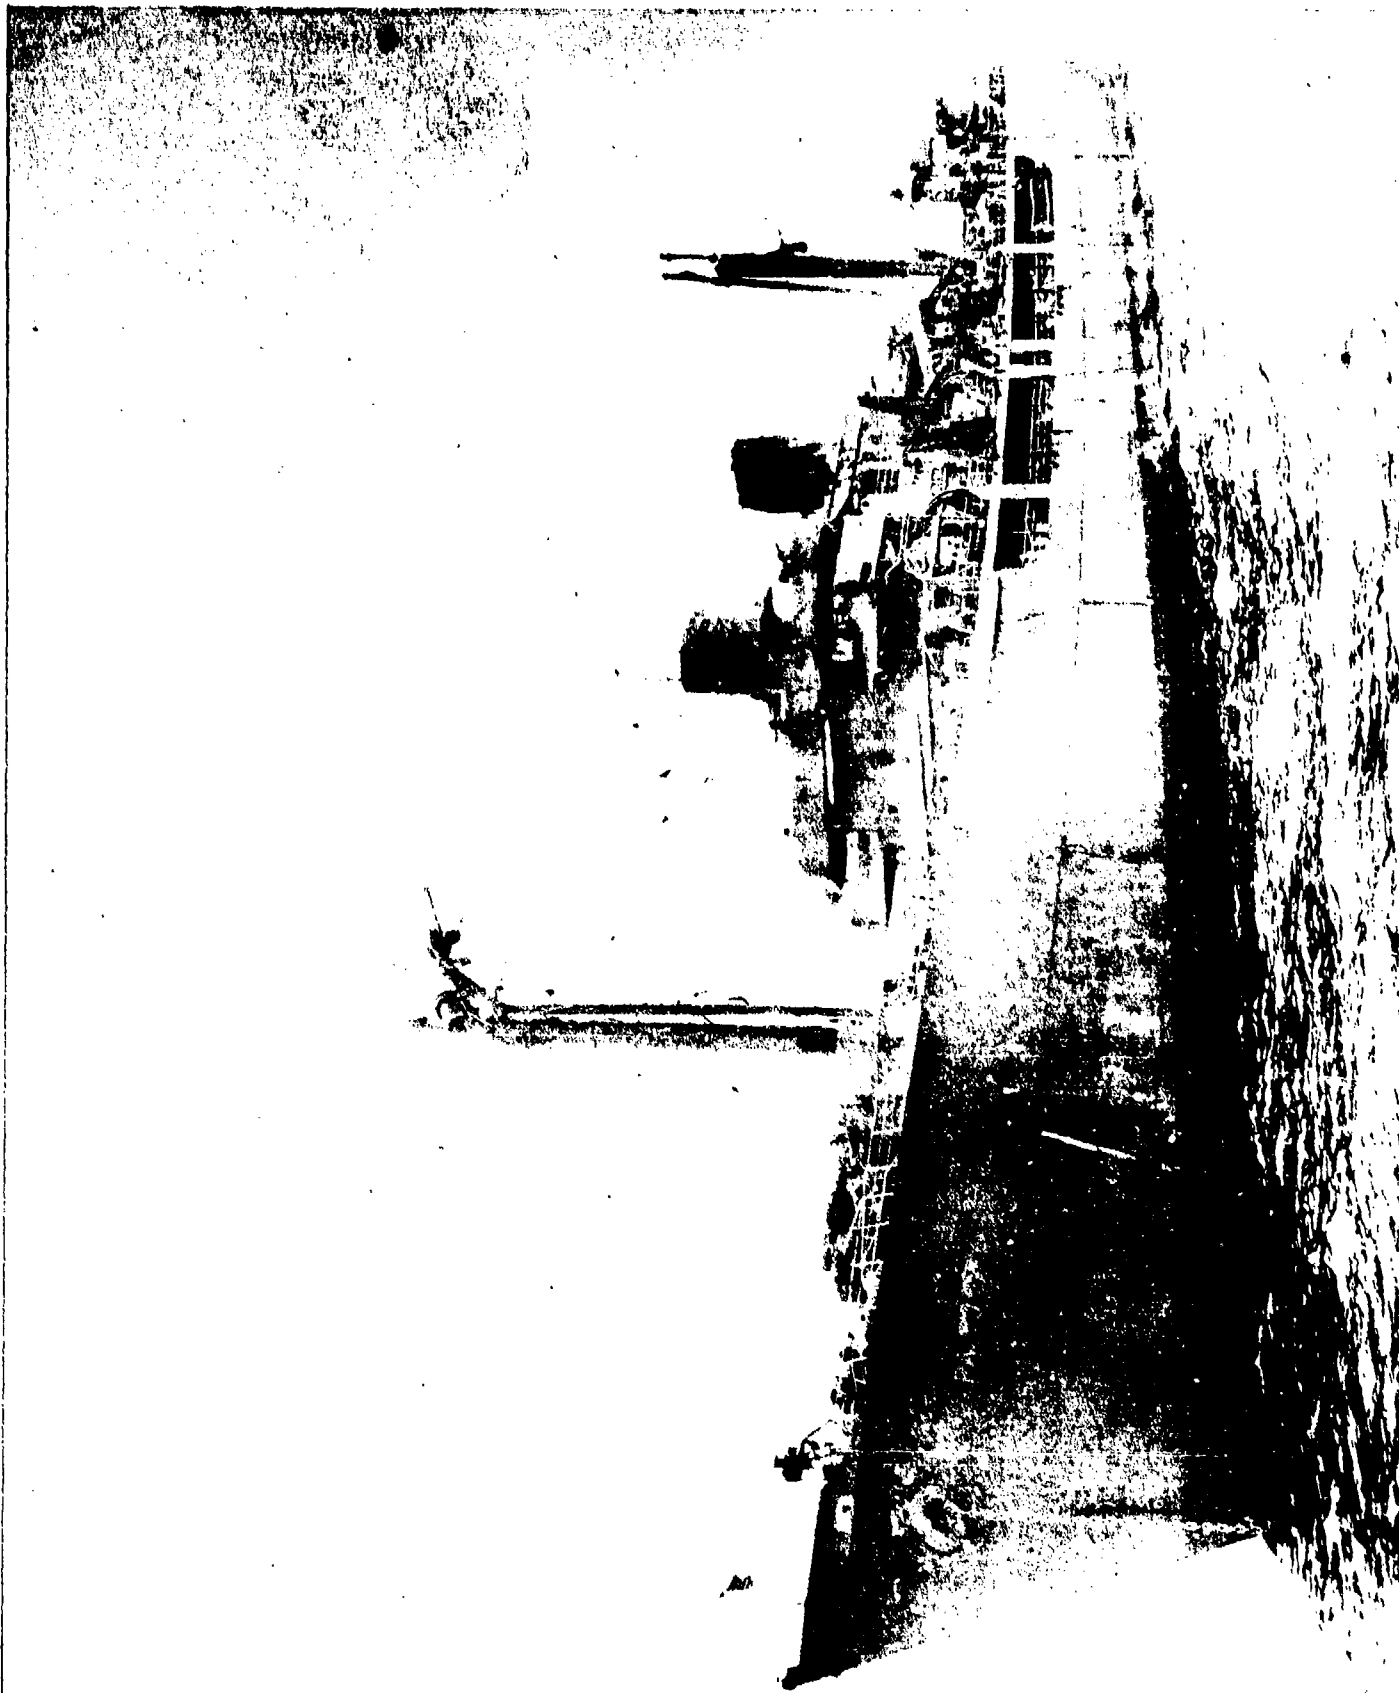
AA-CR-227-49-119. After test. Port Bow view.

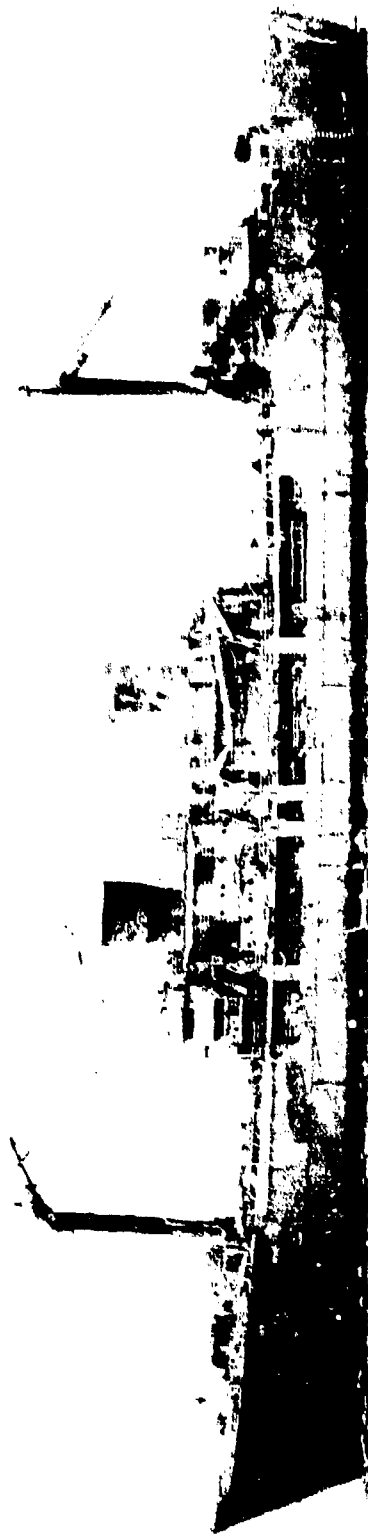
AA-CR-227-49-120. After test Port Beam view.

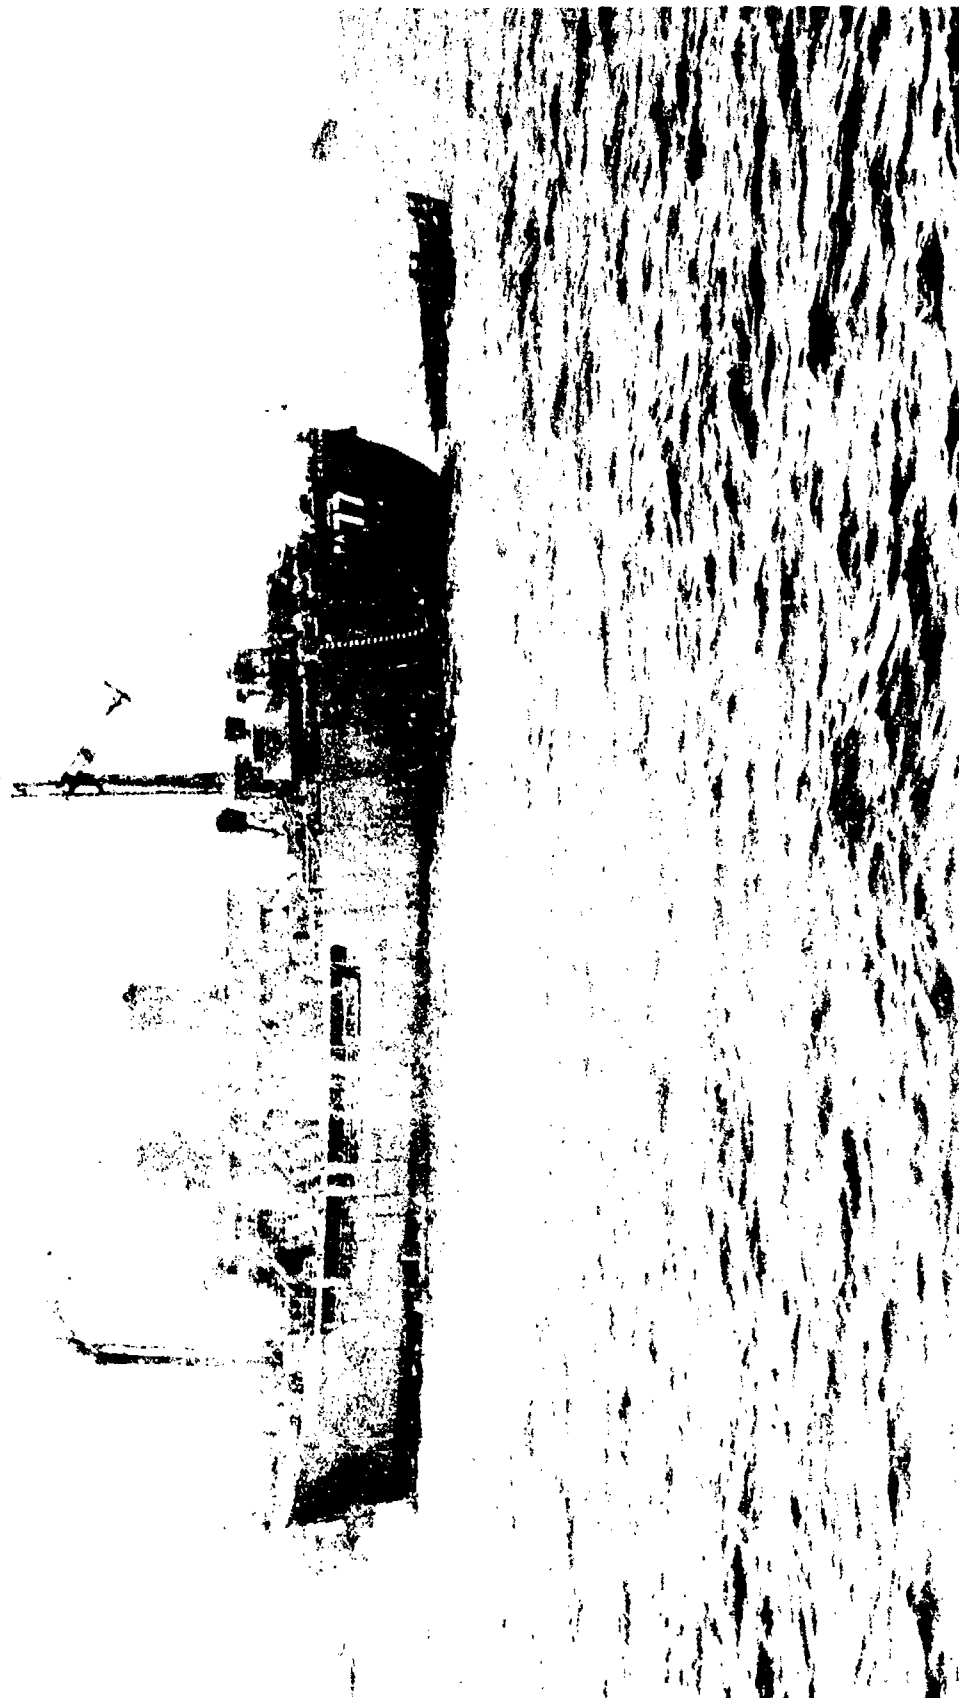
AA-CR-227-49-113. After test. Port Quarter view.

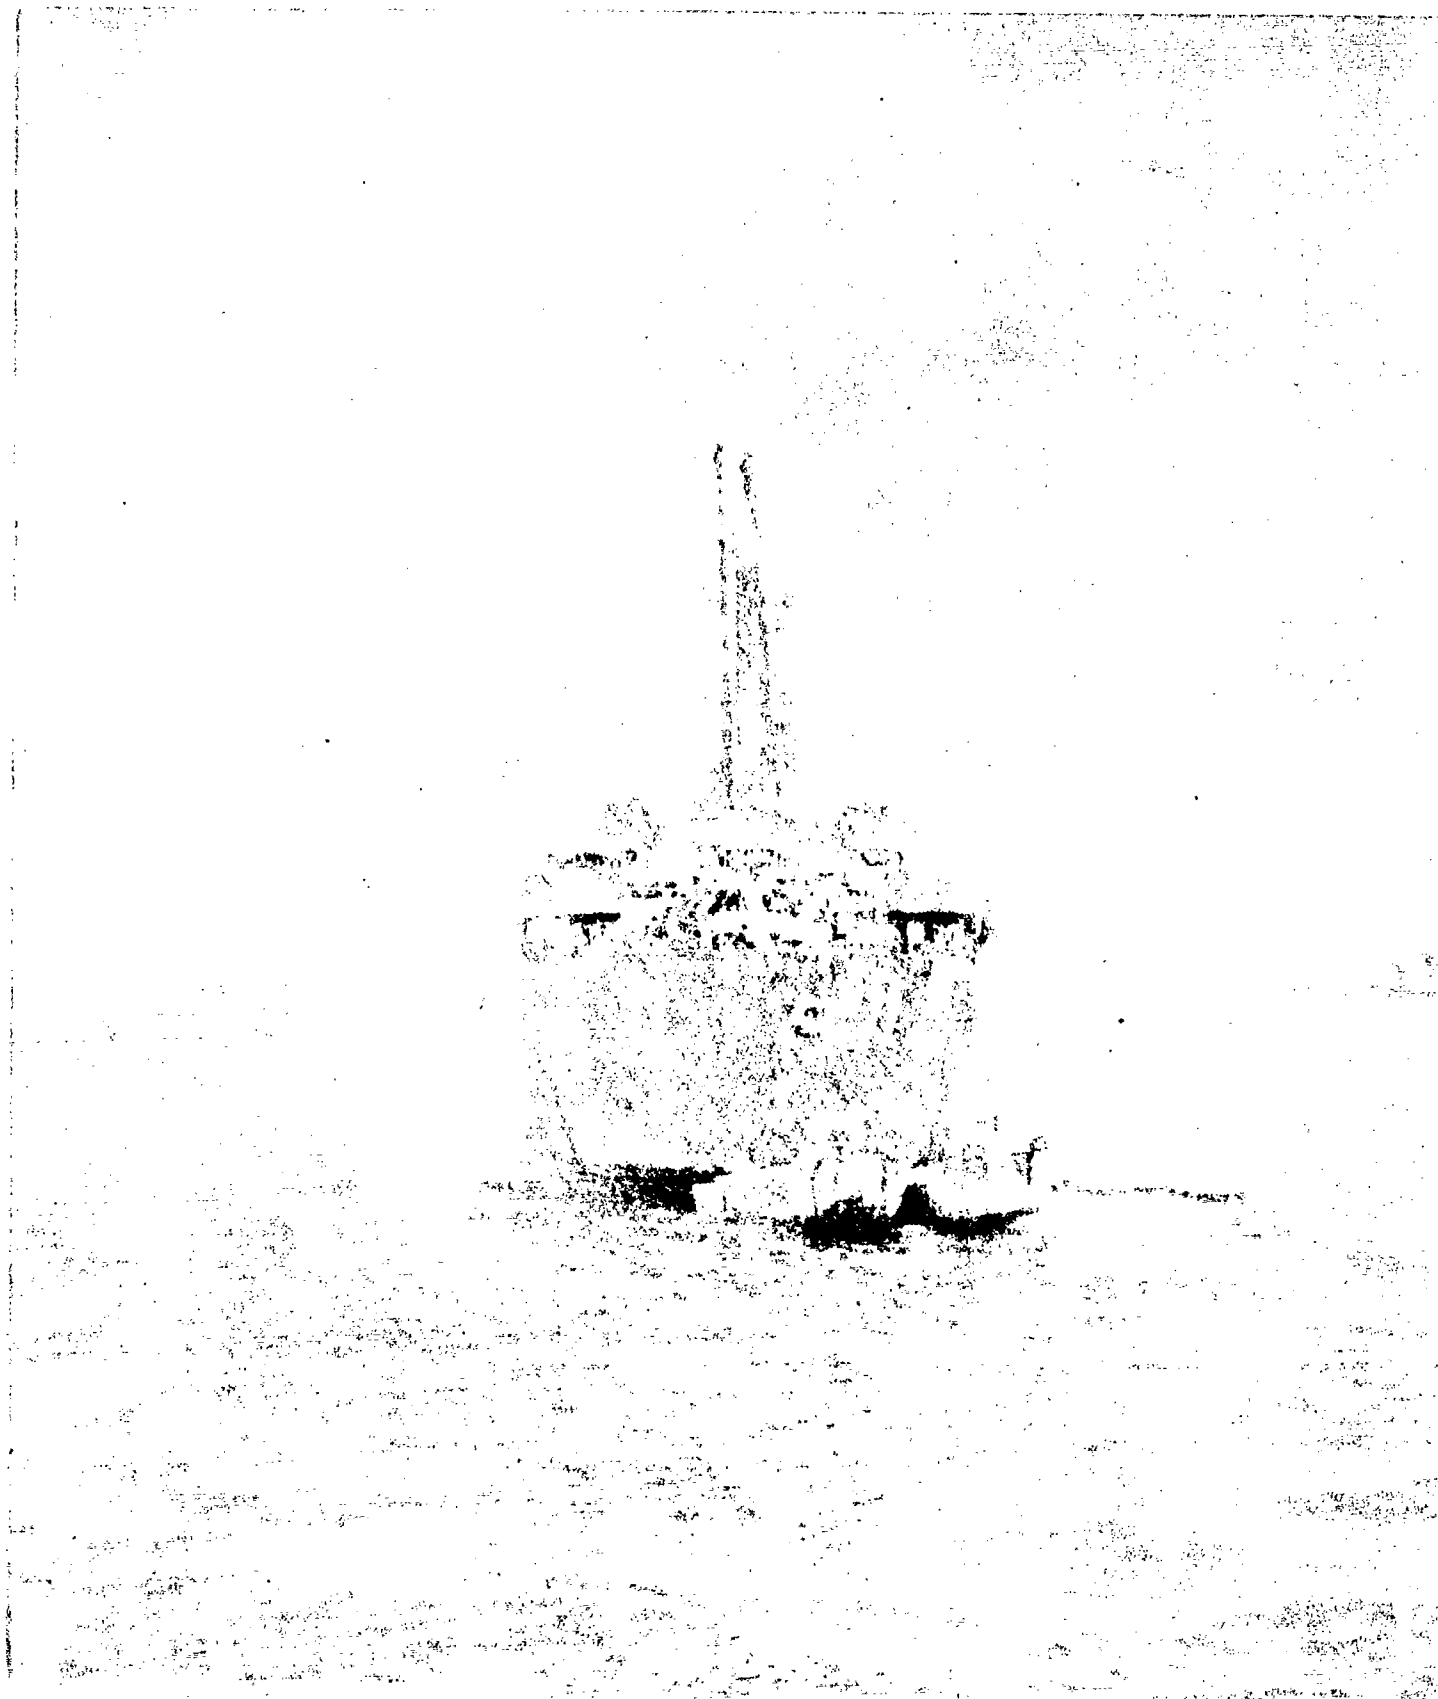
AA-CR-227-49-114. After test. Stern view.

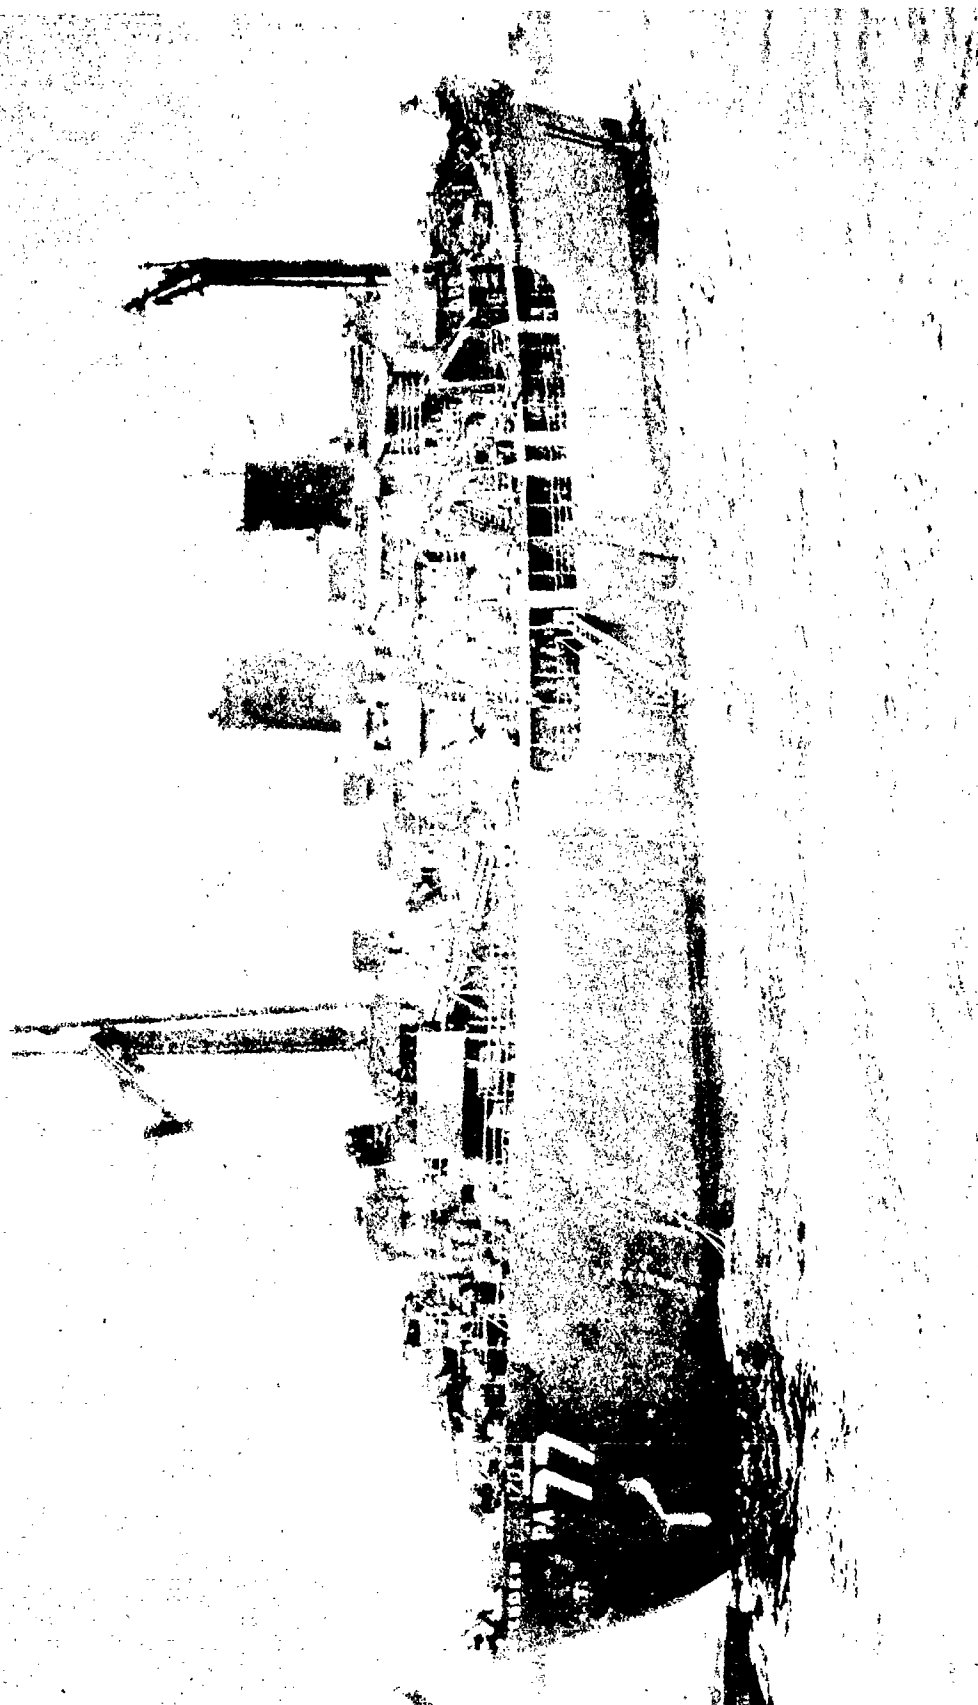
AA-CR-227-49-115. After test. Starboard Quarter view.

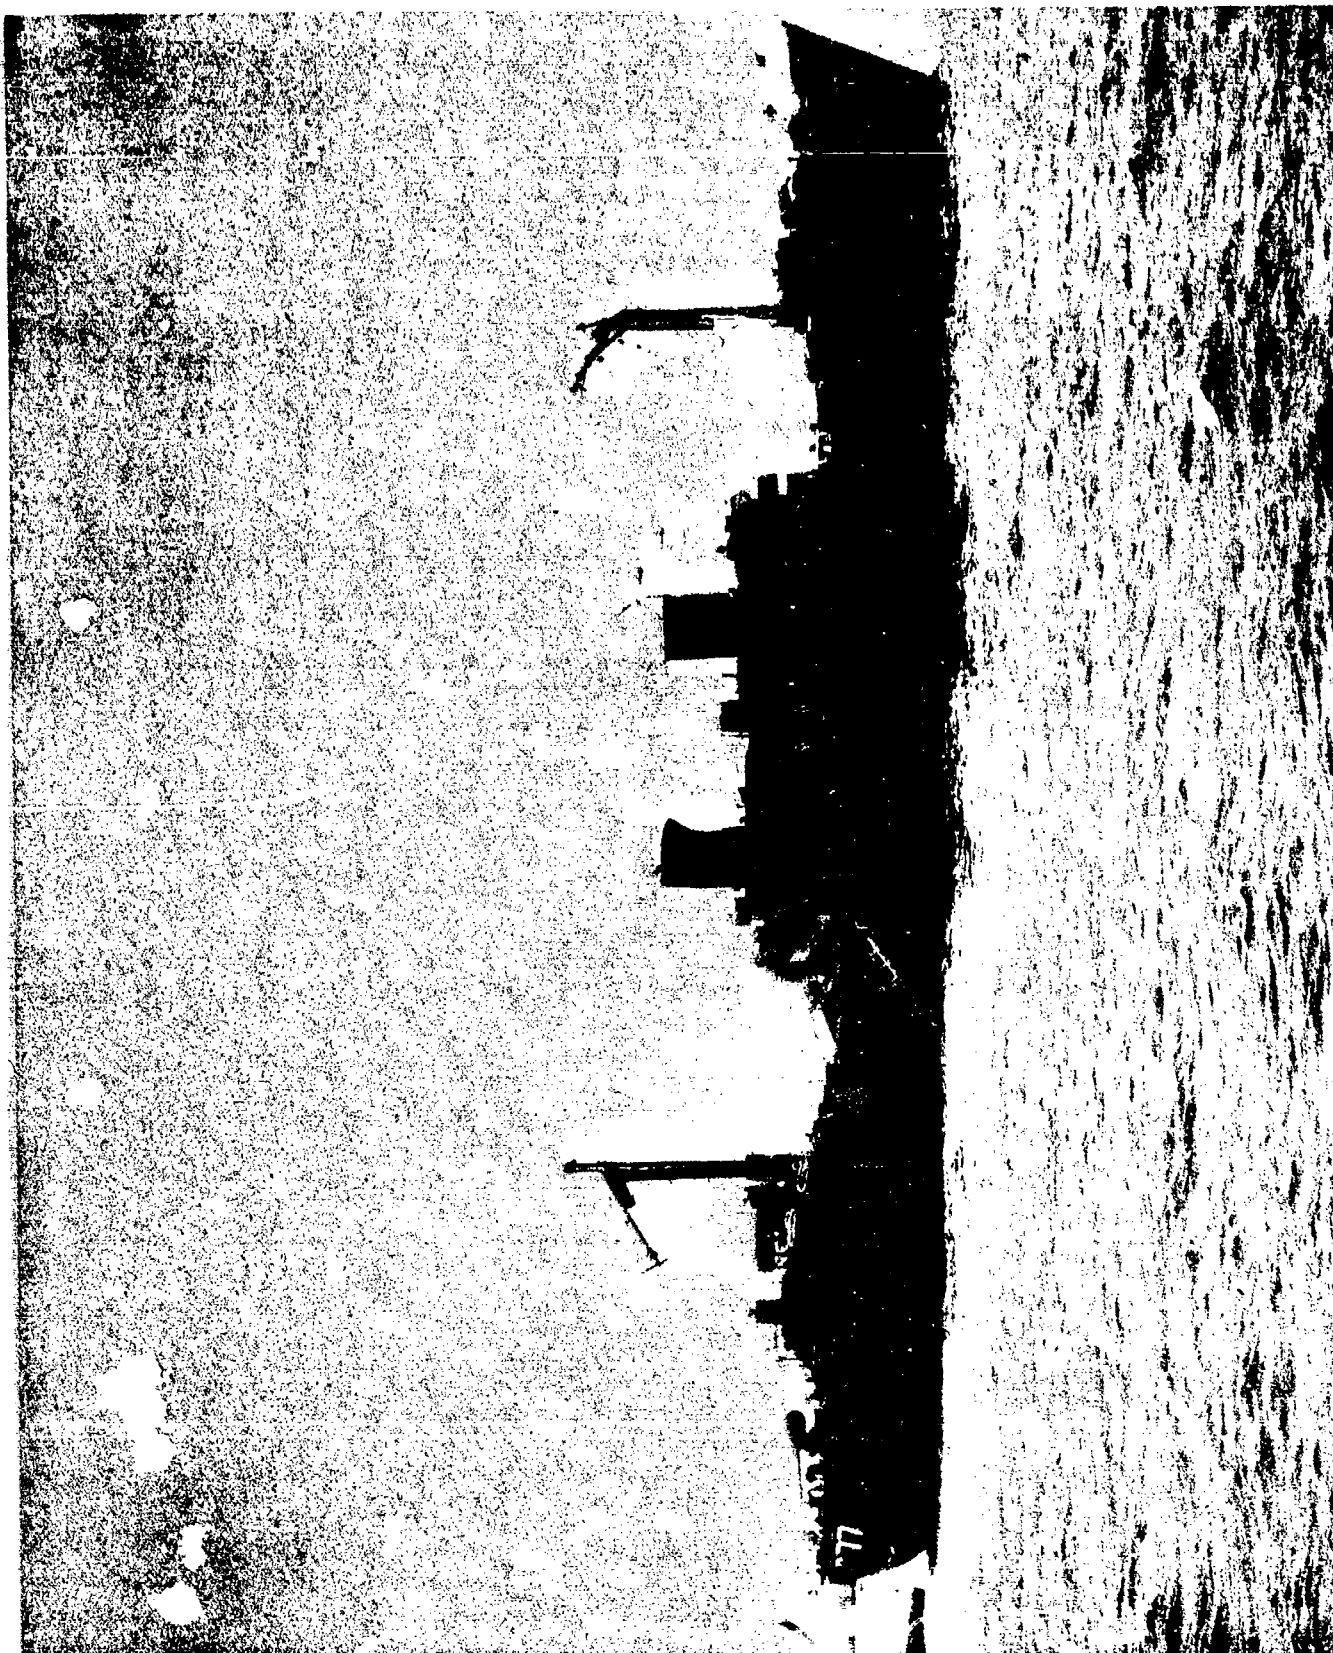
AA-CR-227-49-116. After test. Starboard Beam View.

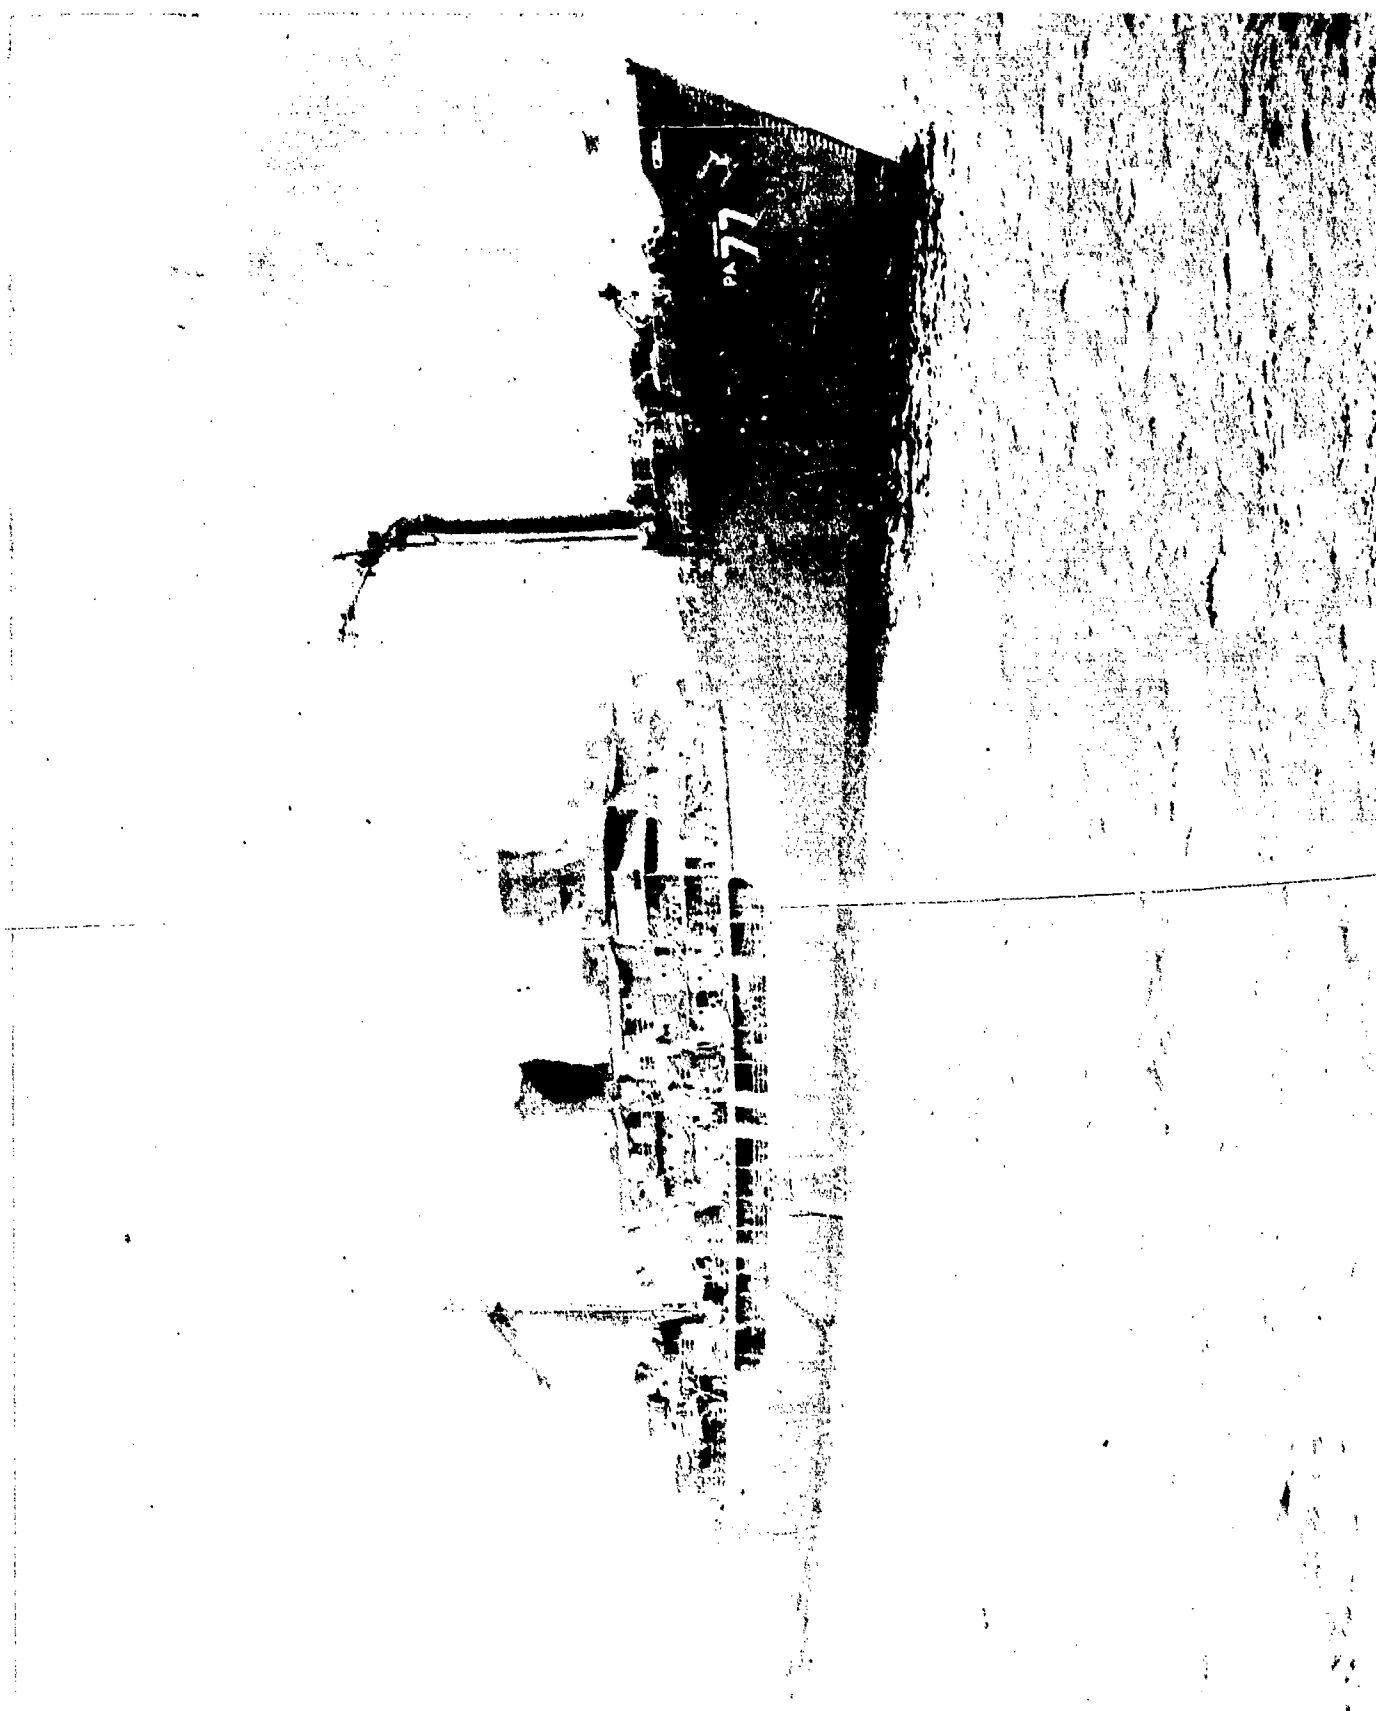
AA-CR-227-49-117. After test Starboard Bow view.

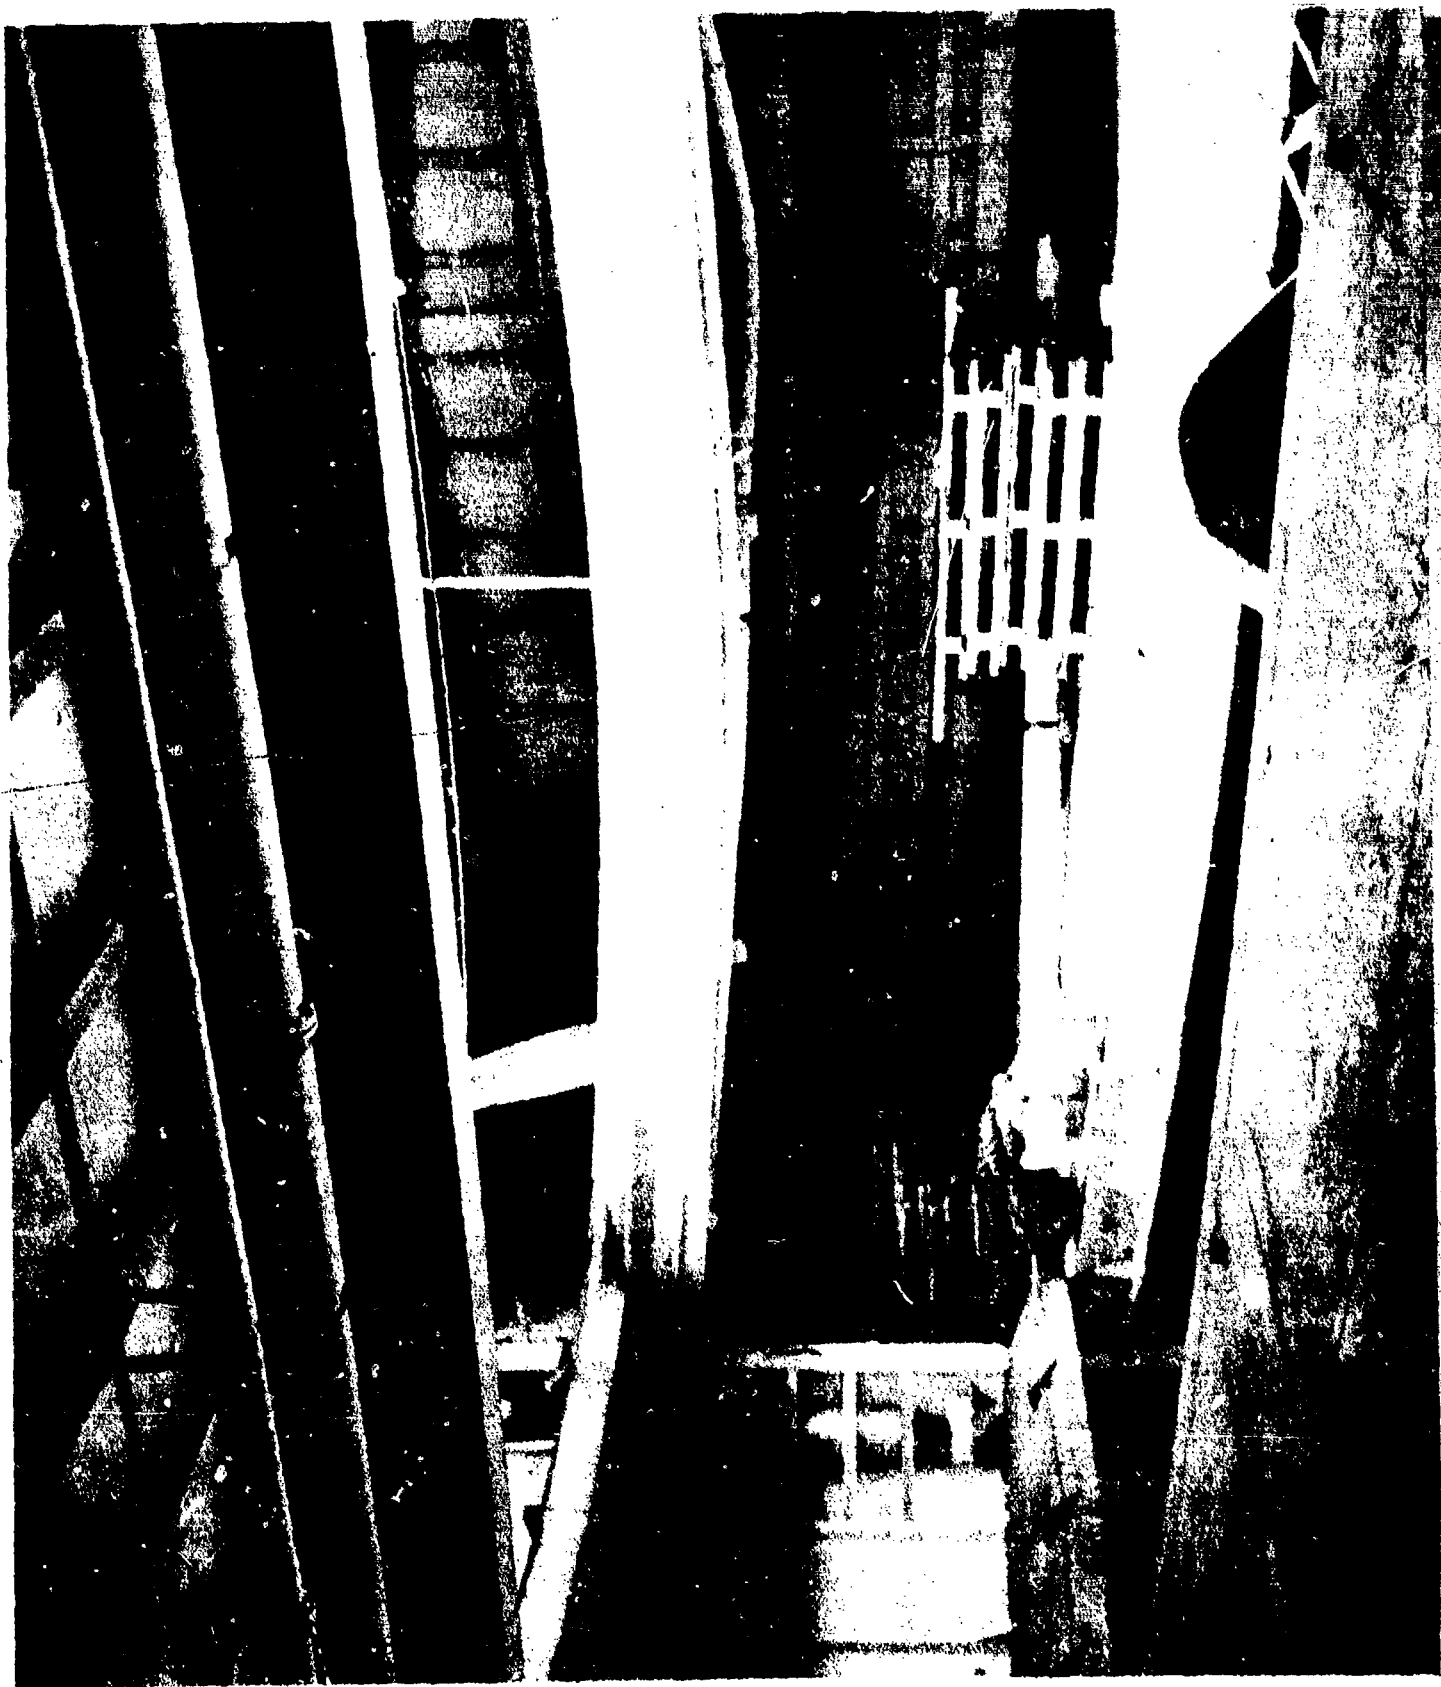
AA-CR-80-1907-5. Looking forward and to starboard on first platform in forward cargo hatch area showing deflected hatch coamings, starboard, at main deck and first platform levels.

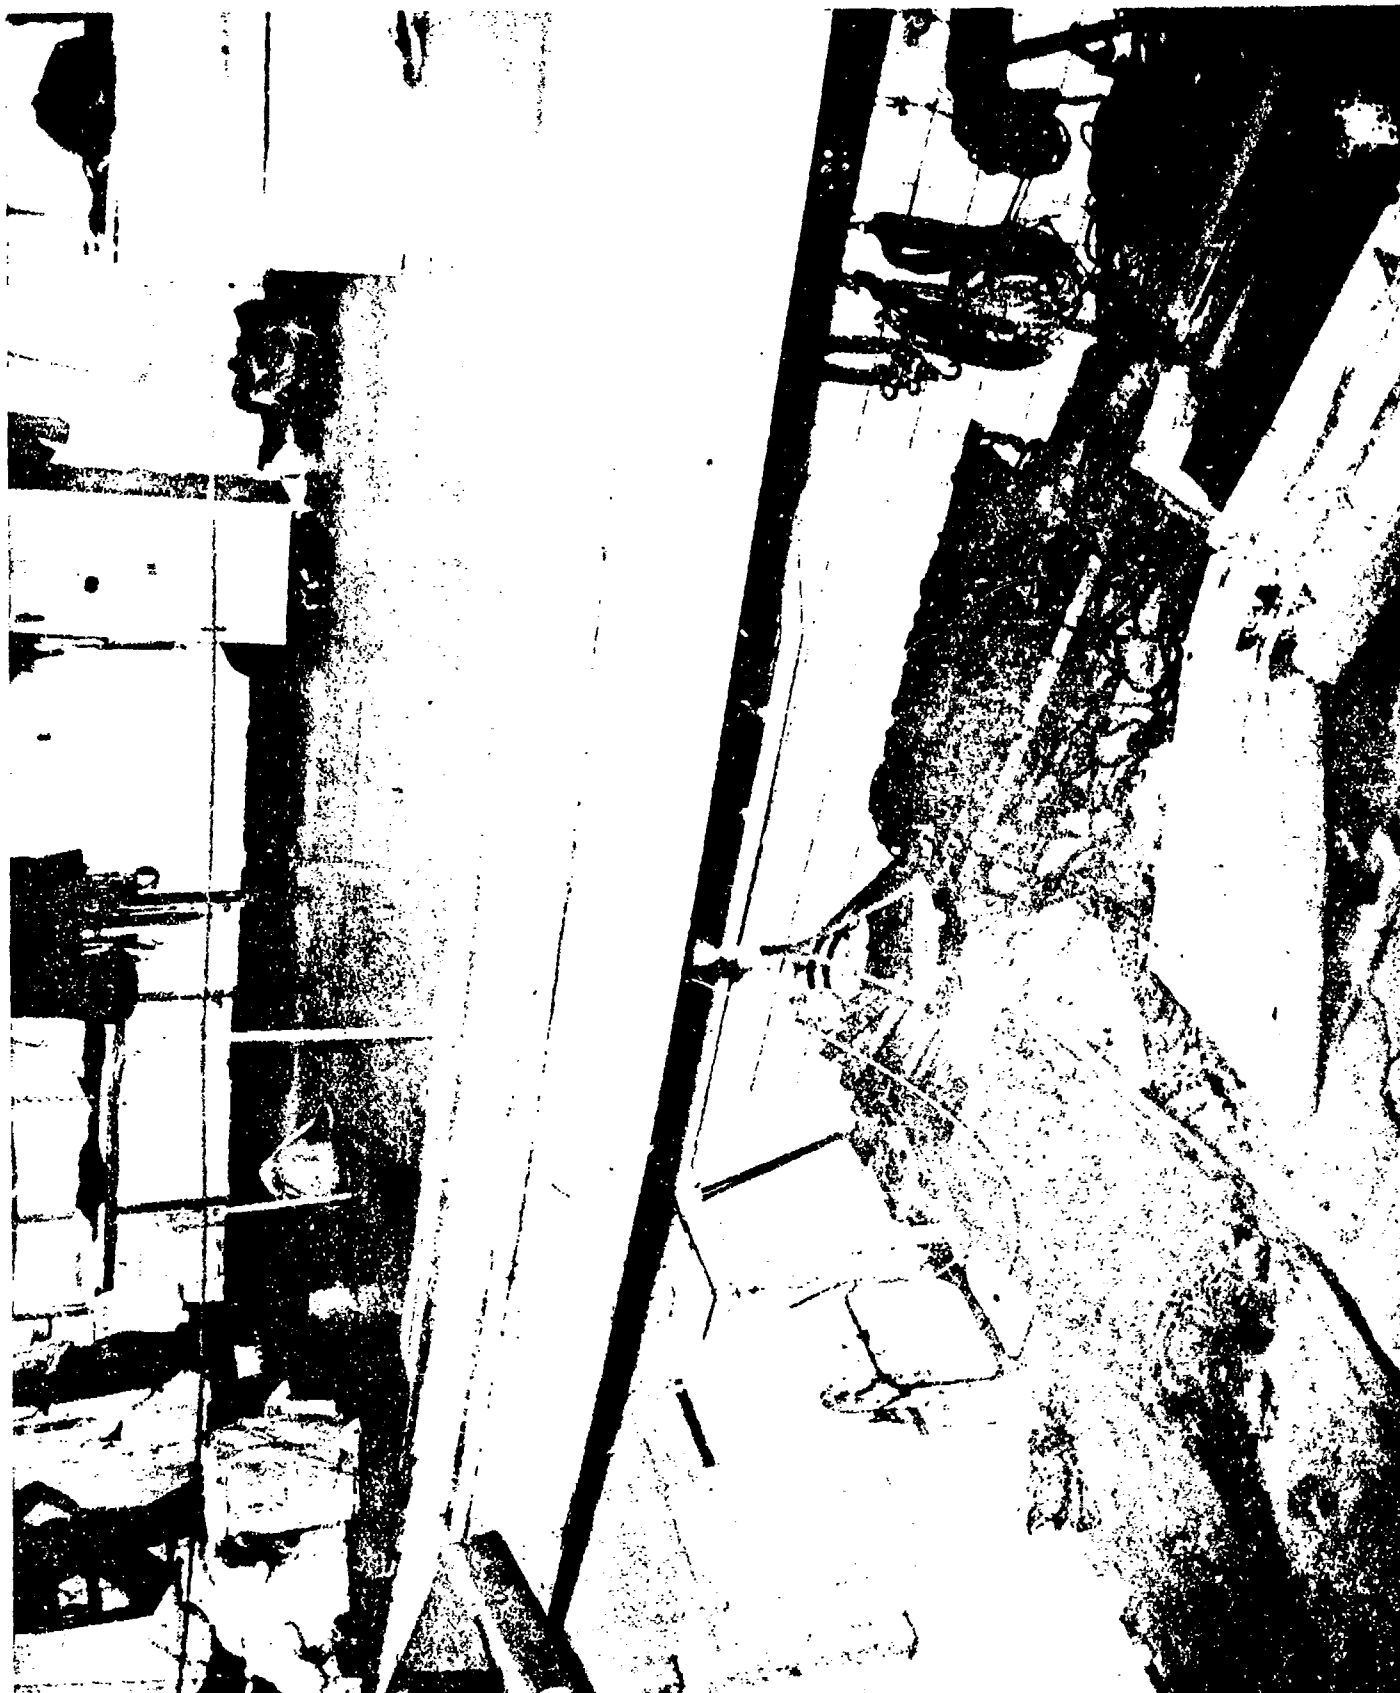
AA-CR-80-1907-12. Looking forward and to starboard in after cargo hatch area showing deflection of starboard coaming at main deck level and pontoons in hold.

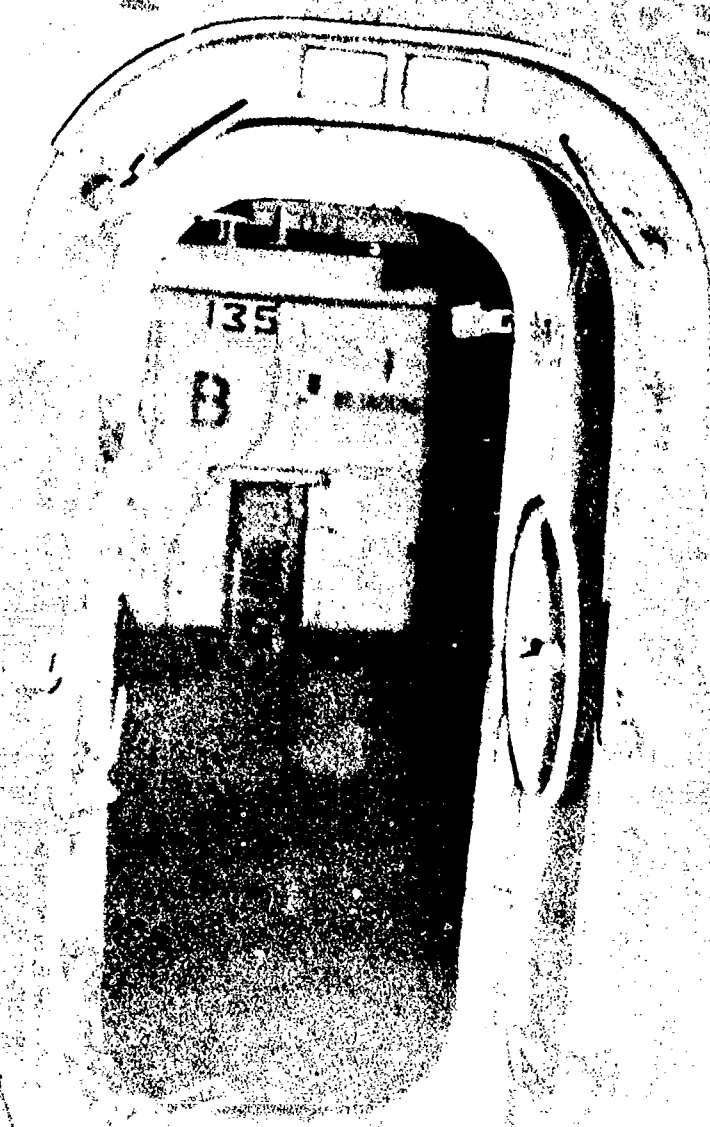
AA-CR-65-1819-2. Lookingaft in main deck, well, starboard, showing damage after bulkhead 122.
